Year End Report
Mount Kemble Lake
Morristown, New Jersey

January 21, 2011

Year End Report
 2010 Lake Management Program/ Action Plan
 Mount Kemble Lake

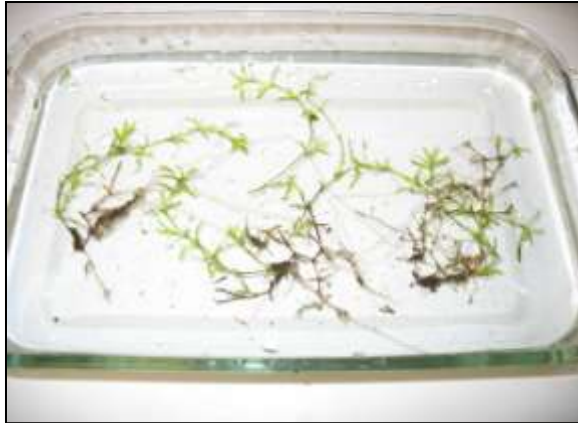
Southern Naiad (*Najas guadalupensis*.
Common Names: Southern water nymph,
bushy pondweed. **Native**.): Southern
naiad is an annual aquatic plant that can
form dense stands of rooted vegetation. Its
ribbon-like leaves are dark-green to
greenish-purple, and are wider and less
pointed than slender naiad. Flowers occur
at the base of the leaves, but are so small,
they usually require magnification to
detect. Southern naiad is widely

distributed, but is less common than slender naiad in northern zones. Southern naiad reproduces by seeds and fragmentation.

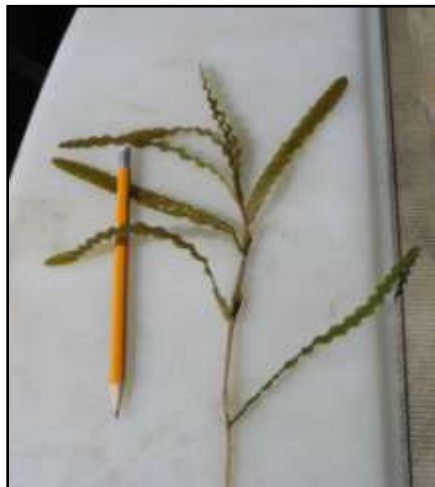
Curly-leaf Pondweed (*Potamogeton crispus*.
Common Name: curly-leaf pondweed. **Invasive**.):
Curly-leaf pondweed has spaghetti-like stems that
often reach the surface by mid-June. Its submersed
leaves are oblong, and attached directly to the stem
in an alternate pattern. The margins of the leaves are
wavy and finely serrated, hence its name. No
floating leaves are produced. Curly-leaf pondweed
can tolerate turbid water conditions better than most
other macrophytes. In late summer, Curly-leaf
pondweed enters its summer dormancy stage. It
naturally dies off (often creating a sudden loss of
habitat and releasing nutrients into the water to fuel

algae growth) and produces vegetative buds called turions. These turions germinate when the water gets cooler in the autumn and give way to a winter growth form that allows it to thrive under ice and snow cover, providing habitat for fish and invertebrates.

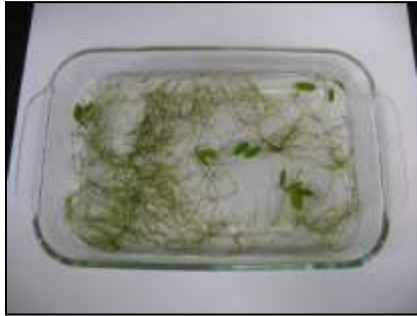
Variable-leaf Pondweed (*Potamogeton diversifolius*. Common Names: Water-thread pondweed, variable-leaf pondweed, snailseed pondweed. **Native**.): Variable-leaf pondweed have freely-branched stems emerging from slender rhizomes. The submersed leaves are narrow and linear with one obvious midvein bordered by a row of hollow cells. The floating leaves are shaped like an ellipse, but are usually less than 4 cm long, Variable-

leaf pondweed fruit spikes are produced in two distinct forms. It occurs in lakes, ponds, rivers and streams and prefers soft sediment and water less than 2 meters deep. Waterfowl graze on the fruit, and local fauna often graze on the stems and leaves.

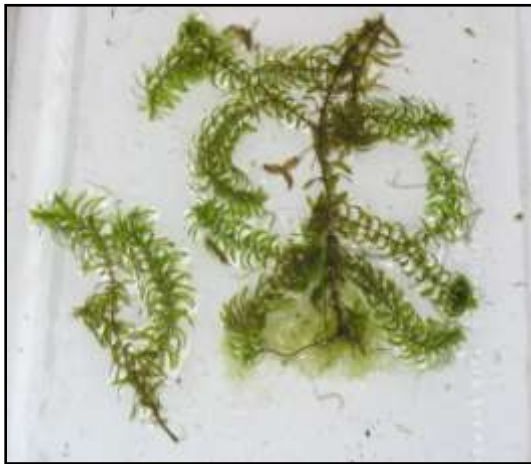
Common Waterweed (*Elodea Canadensis*: Common Names: elodea, common waterweed. **Native**.): Common waterweed has slender stems that can reach a meter in length, and a shallow root system. The stem is adorned with lance-like leaves that are attached directly to the stalk that tend to congregate near the stem tip. The leaves are populated by a variety of aquatic invertebrates. Male and female flowers occur on separate plants, but it can also reproduce via stem fragmentation. Since common waterweed is disease resistant, and tolerant to

low-light conditions, it can reach nuisance levels, creating dense mats that can obstruct fish movement, and the operation of boat motors.

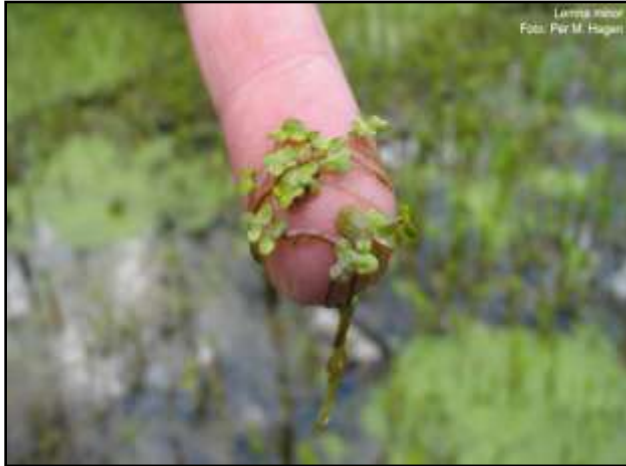
Small Duckweed (*Lemna minor*).

Native.) Small duckweed is a free floating plant, with round to oval-shaped leaf bodies typically referred to as fronds. The fronds are small (typically less than 0.5 cm in diameter), and it can occur in large densities that can create a dense mat on the water's surface. Each frond contains three faint nerves, a single root (a characteristic used to

distinguish it from other duckweeds), and no stem. Although it can produce flowers, it usually reproduces via budding at a tremendous rate. Its population can double in three to five days. Since it is free floating, it drifts with the wind or water current, and is often found intermixed with other duckweeds. Since it's not attached to the sediment, it derives nutrients directly from the water, and is often associated with eutrophic conditions. It over winters by producing turions late in the season. Small duckweed is extremely nutritious and can provide up to 90% of the dietary needs for waterfowl. It's also consumed by muskrat, beaver and fish, and dense mats of duckweed can actually inhibit mosquito breeding.
