2011 Year End Report

Mount Kemble Lake Association, Inc.
Morristown, New Jersey

Lake Management Program
Mount Kemble Lake

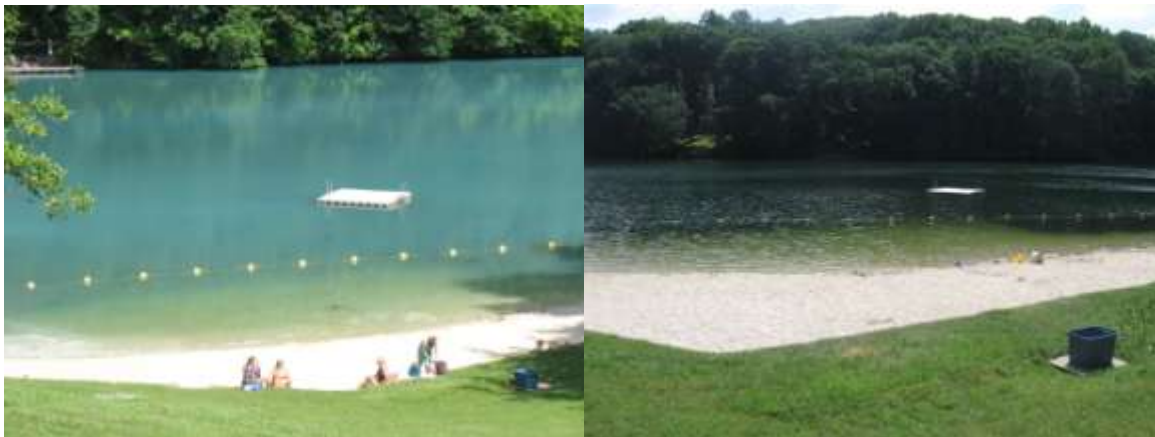
Photo Left. View from Lake Trail West of Mount Kemble Lake following Alum application.

Photo Right. View from Lake Trail West of Mount Kemble Lake thirteen days following application.

During the 2011 management season Mount Kemble Lake experienced clarity measurements as low as six inches of visibility. A treatment of aluminum sulfate (alum) was applied to bind phosphorus in the water column as well as within the sediment. The additional benefit of the alum application is the substantially increased water clarity. Prior to the application the recorded value of water clarity was three feet. Following the treatment the Secchi measurement displayed a ten foot value.
